## Inspection Report

| Vessel name: | MV ANNA-MARIA | IMO No.: | 9407469 |

Attended on board as per customer's requirement to carry out inspection of hatch cover during DD in Fujian Huadong Shipyard.

Hatch cover: Folding type, total 5 cargo holds.  
Maker: Macgregor

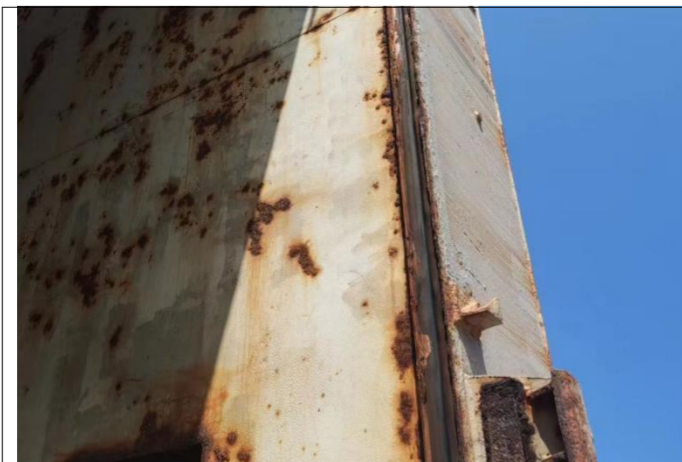
the condition of the HC backside and skirt plate

- Hatch cover back side and skirt plate (lower part of hatch cover side plate) were rusty, suggest to be de-rusted and paint .
- The packing channel in all hatch cover were rust, suggest to be sandblasted first after remove the rubber packing. And then check the packing channel condition again, damaged packing channels to be renewed.

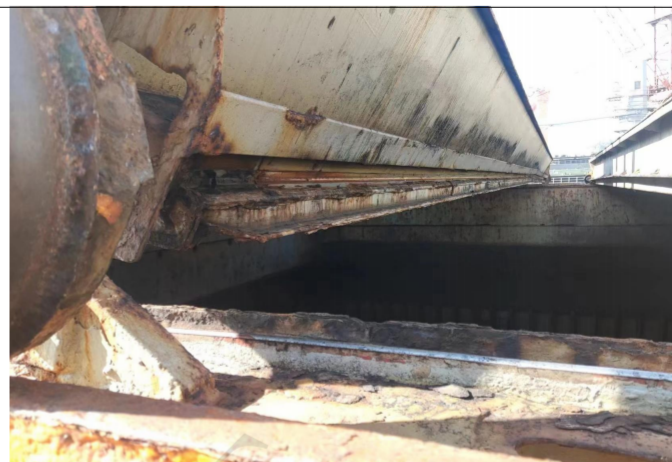
Rubber channel was rusty

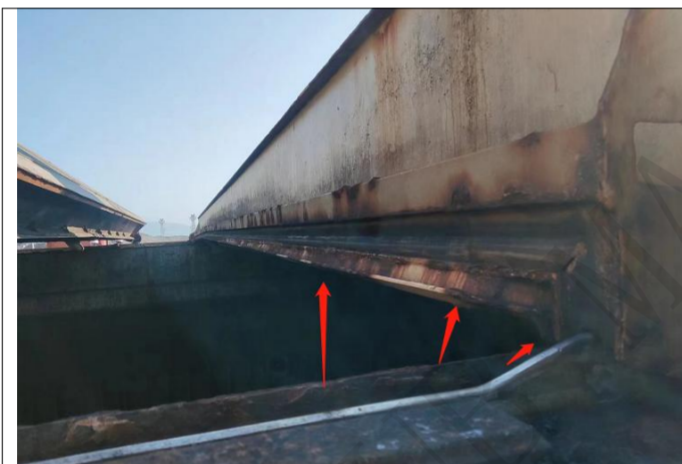
the condition of drain channel

- Hatch cover drain channels are in bad condition, it is recommended to replace the corroded channels after sandblasting or rust removal.
- All resting stools (mating plates) are corroded. Suggest de-rusting and grinding to Smooth.

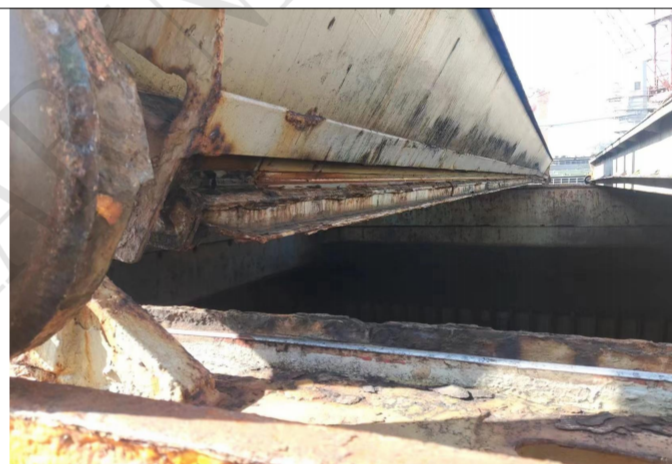
Rubber channel was rusty

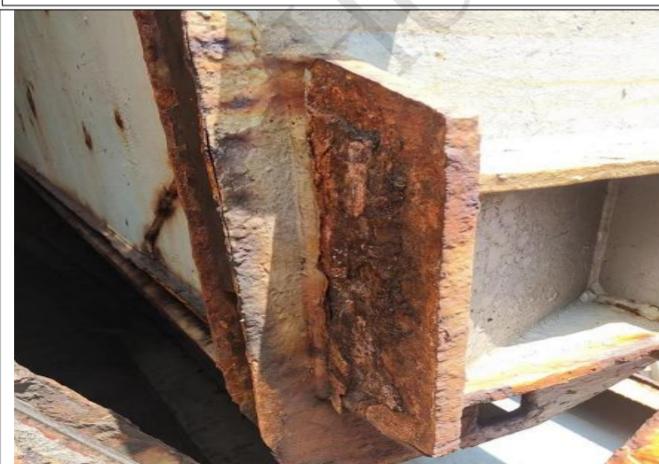
Mating plate was rusty

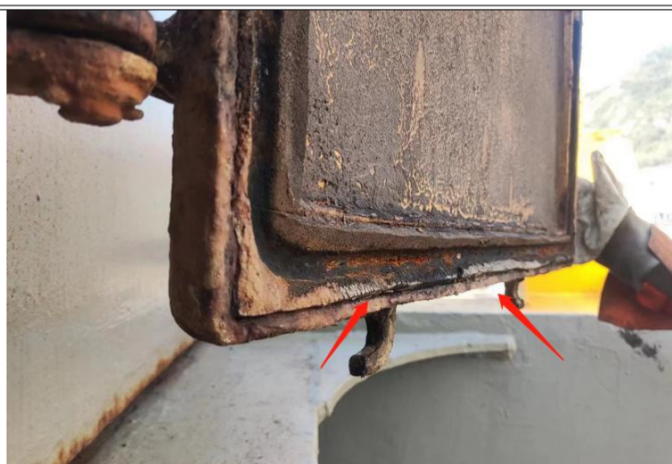
Rubber packing of ventilation

- Rubber retain channel of all ventilation doors were rusty. Suggest to remove the ventilation doors for maintenance and renew the rubber packing.
- **We found too much wear from intermediate hinge and end hinge, now hatch cover can not be full opened. Too much gap from intermediate hinge, it is very dangerous for hatch cover operation, the pin may come out!! Hatch cover need to be moved ashore for repair. Suggest to do build-up welding and boring the intermediate hinge hole and the end hinge hole.**

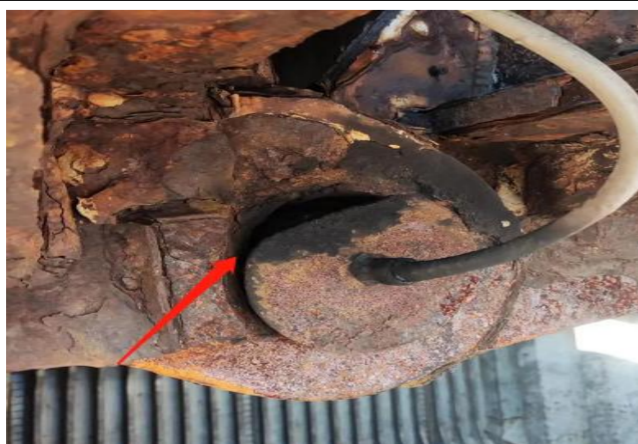
Intermediate hinge was worn out heavily

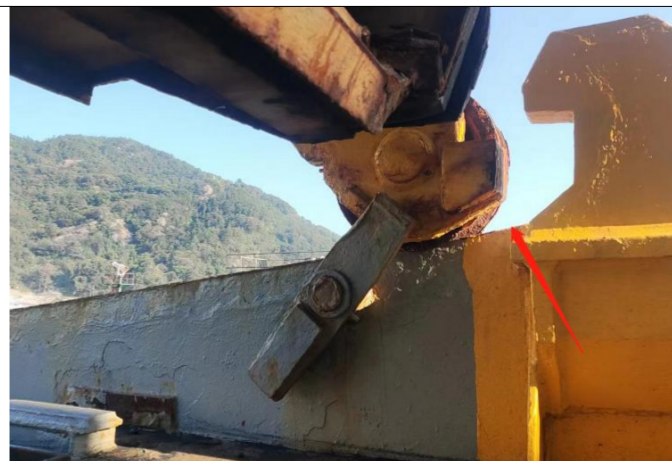
Some covers can not full open

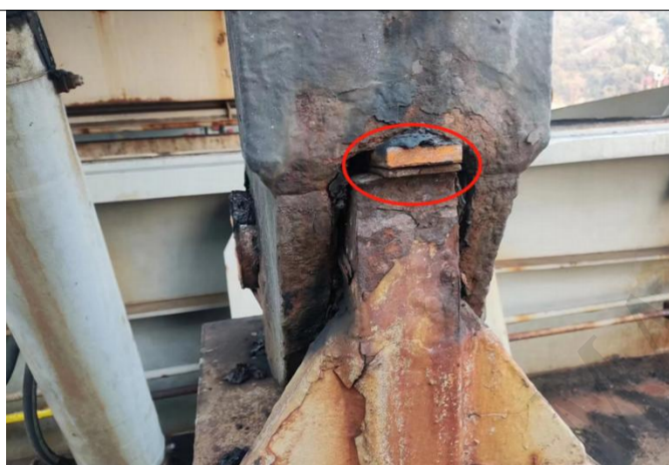
End hinge was worn out heavily

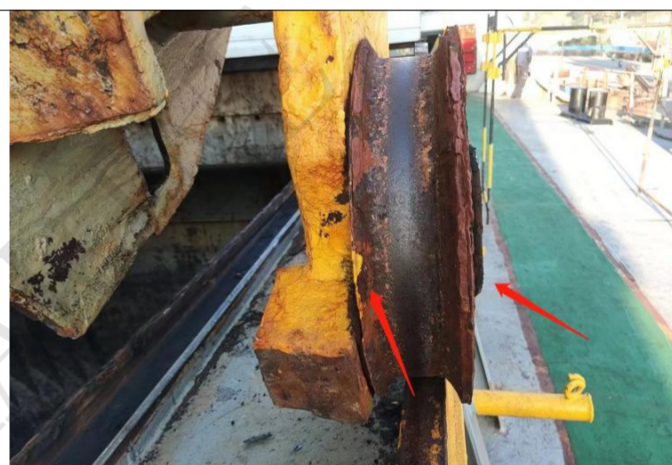
- We found that all running wheels were worn out heavily. It is very dangerous for hatch cover operation. According to spare list of shipside, ship have spare parts of whole ship including bush. Suggest to replace all running wheels.

Running wheel was worn out heavily

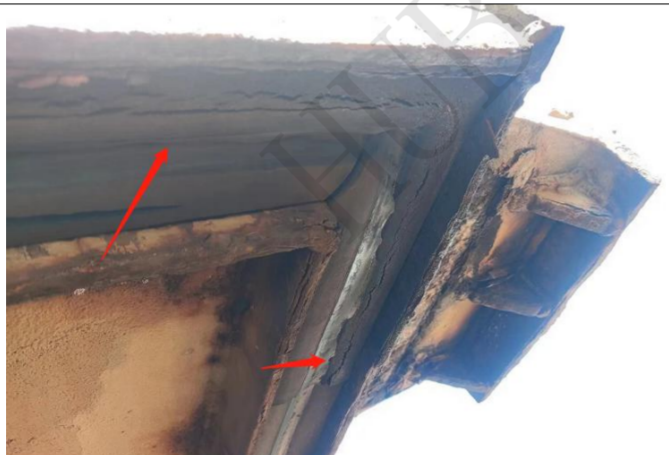
the condition of rubber packing

- Most of hatch cover rubber packing are too much over-compressed and permanent deformed, we suggest to renew all rubber packing and also repair the rusty rubber channels. After renew the rubber packing, we will make measurement and adjustments for hatch cover resting pads and guide stoppers to ensure hatch cover in proper rubber compression and good weathertightness.
- According to shipyard removed rubber packing of meeting joint, we found that rubber doubler was installed before in NO.1 and NO.2. Suggest to install original rubber doubler before install rubber packing in NO.1 and NO.2 meeting joint.
- Hose test / UT test should be carried out after complete all repairs.

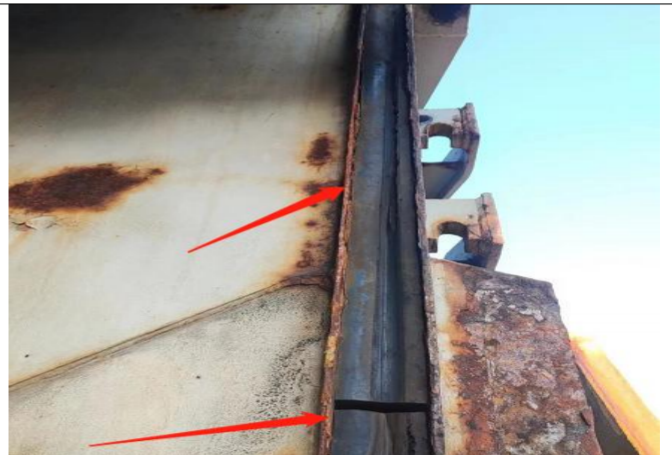
the condition of rubber packing

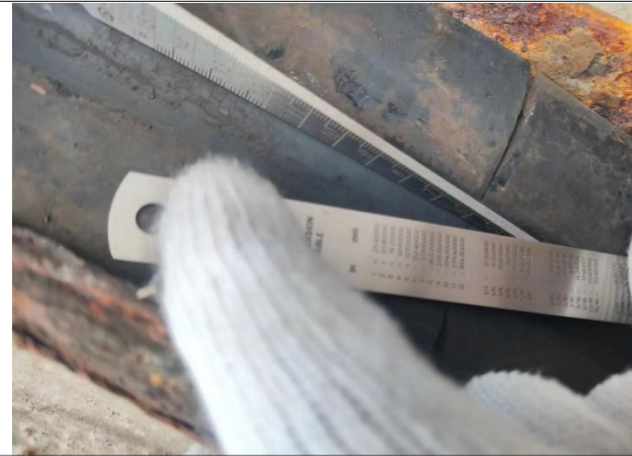
the condition of rubber packing

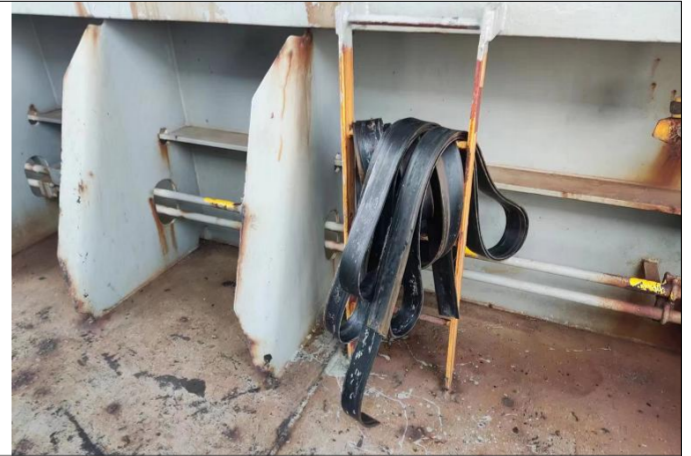
Rubber doubler of meeting joint

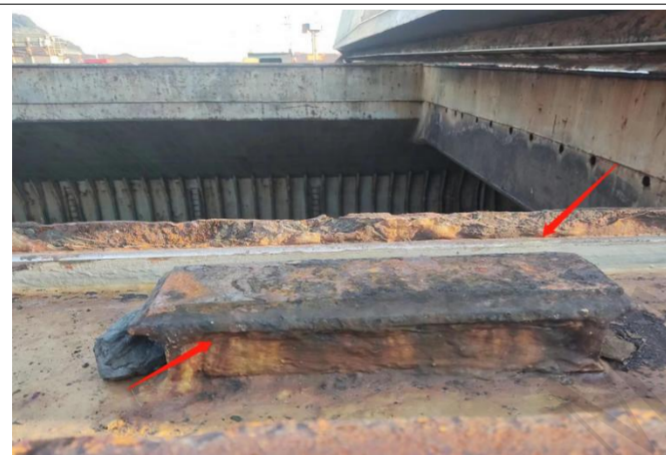
Resting pad was rusty

- Steel to steel bearing pad system. The bearing pads which would cause hatch cover sitting on coaming. The bearing pads will be adjusted by welding one shim plate on the top of resting pads. The bearing pads will be measured and adjusted in final step after renew the rubber packing.

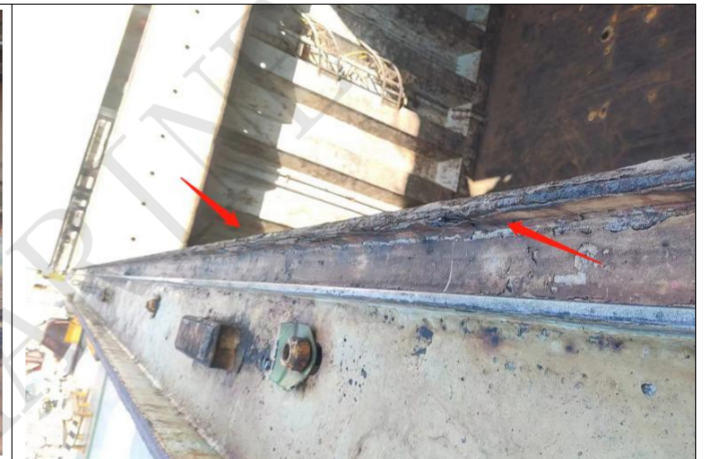
Drain gutter was rusty

- Coaming top including the water drain gutter and rail tack way were rusty, suggest to be sandblasted and paint.
- The crutches of quick acting cleats were rusty, need to be descaled and paint. And quick acting cleats suggested to be removed for maintenance.
- The water drain valve was in normal, and water drain valves to be removed or plug the drain pipes for protecting the valves from sands/ dirty during dock repair. sandblasting. Before ship sailing , all drainage valve to be fit back in position and remove the plug to ensure the water drainage be free.

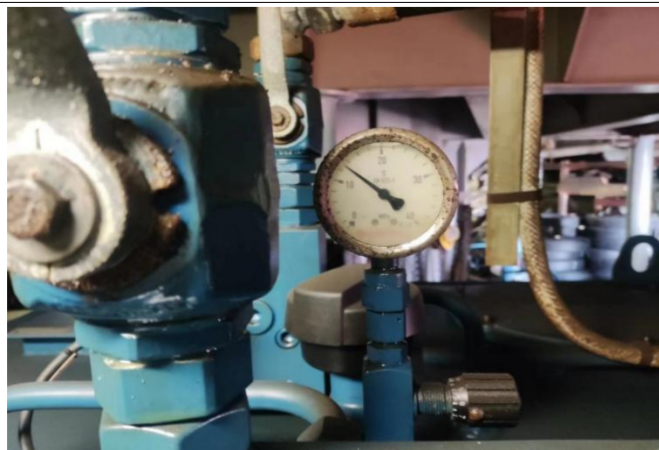
- The working pressure for hydraulic pump were checked that No.1 is 14 Mpa, and No.2 is 14 Mpa. And after adjusted pressure and then checked the pressure No.1 14 Mpa, No.2 15 Mpa. We have to renew No.1 and NO.2 hydraulic pumps due to can not build up the pressure. (normal pressure is 28 Mpa)

Pressure of the pump

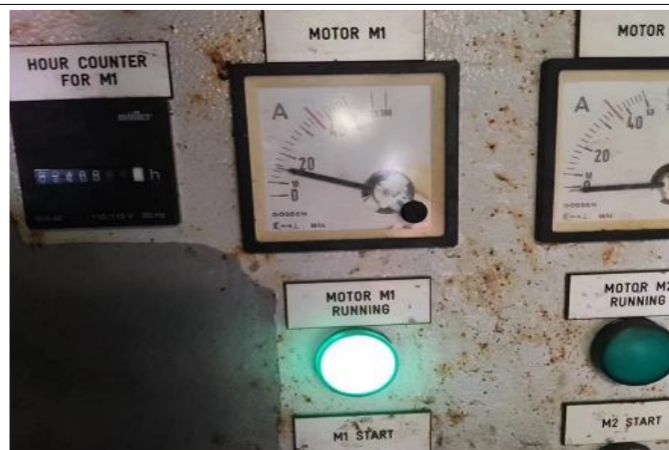
Electric current of the pump

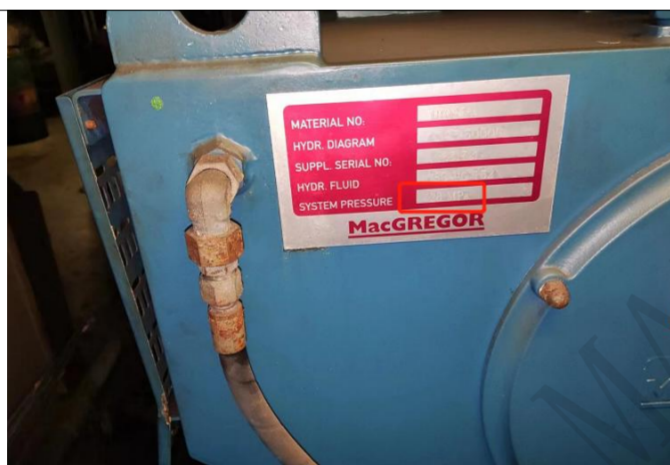
System pressure of pump

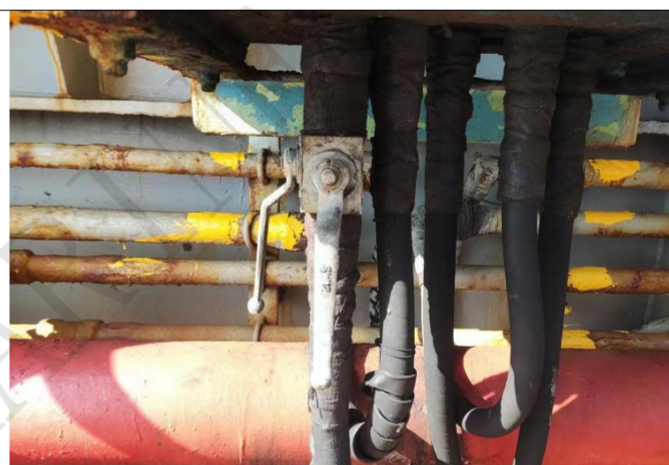
Hose of control valve block

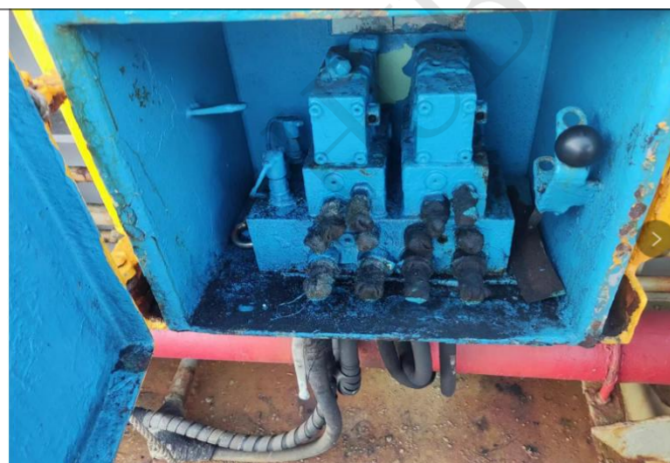
the condition of the control valve block

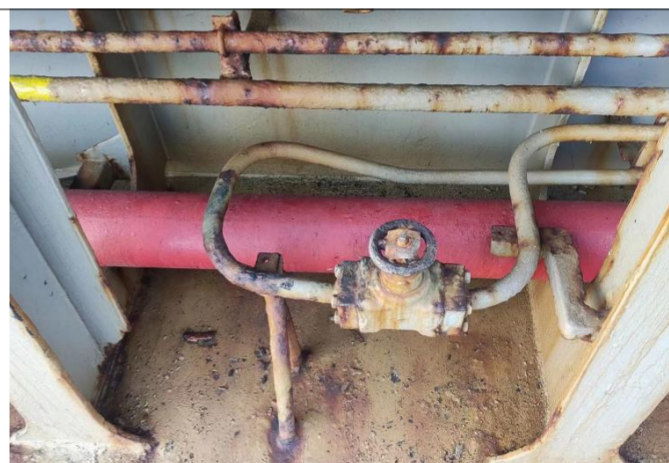
By-pass valve of hatch cover

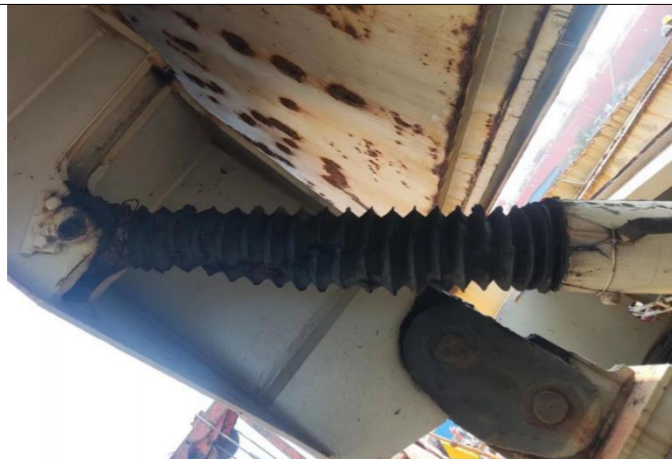
Condition of cylinder

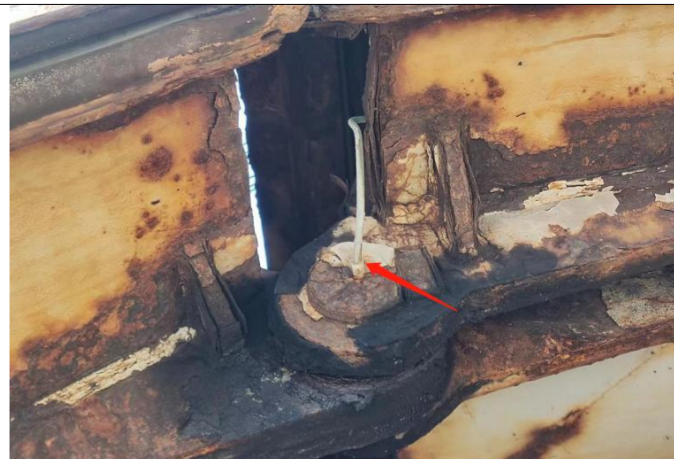
Grease pipe of intermediate hinge
