## SERVICE REPORT

Name of Ship: MV CMA CGM J MADISON Date: 25th Jul-3rd Aug, 2025

Port/Shipyard: SHEKOU & NINGBO PORT

Servcies: LIFEBOAT ENGINE REPAIR

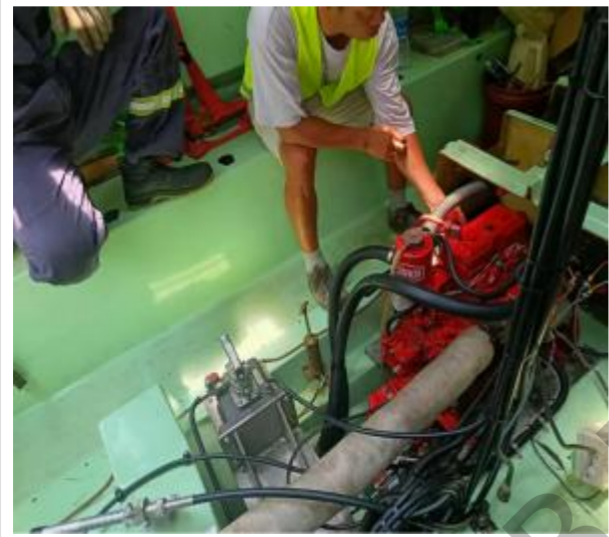
- 1        Testing the engine in th lifeboat
- 2        We infer the problem was the incorrect firing order and broken of the valves.
- 3        Dismantle the engine and offland to our workshop.

Testing the engine.

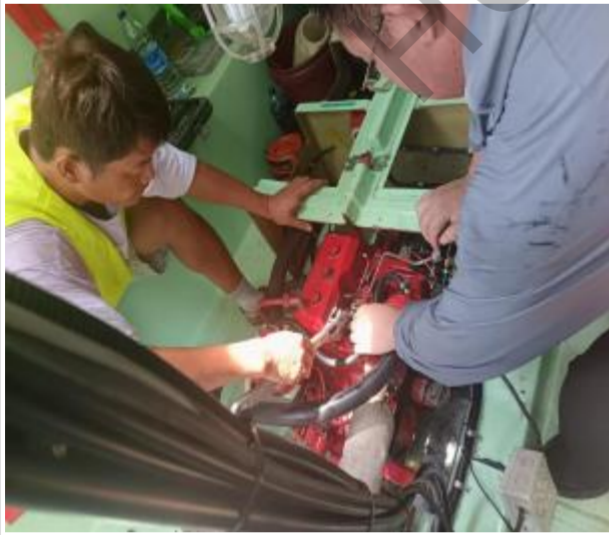
Dismantle the engine.

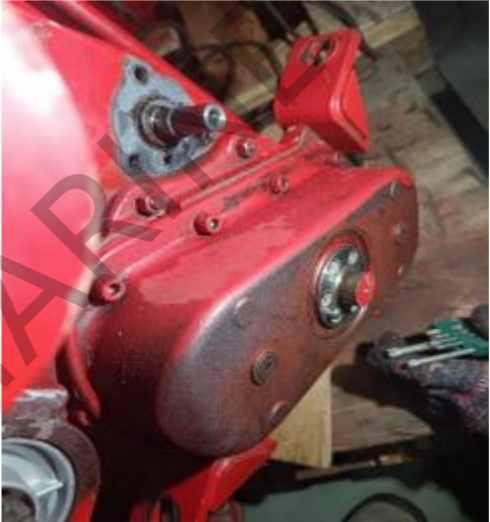
| The two engines arrived at our workshop. | | No.1 crankshaft oil seal leak oil. |

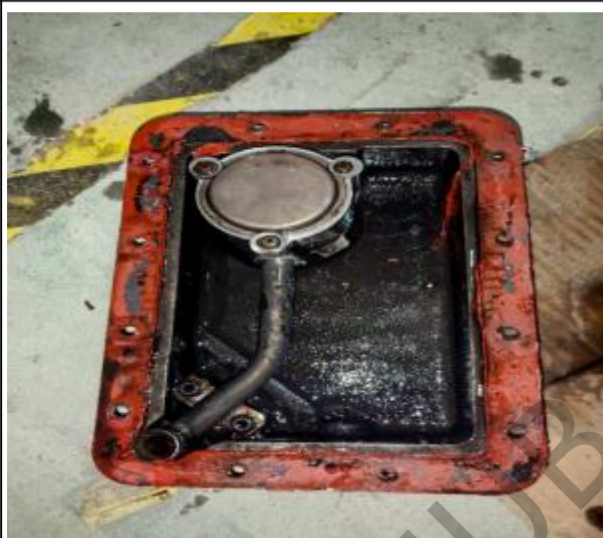
The No.1 oil pan has too much waste oil.

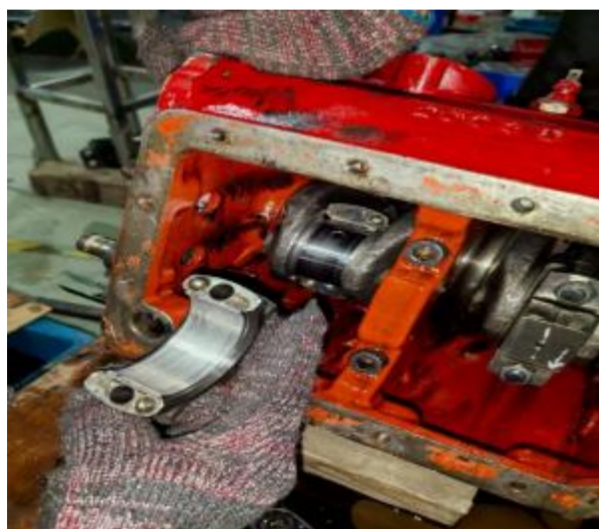
The connecting rod and crankshaft have abrasion.

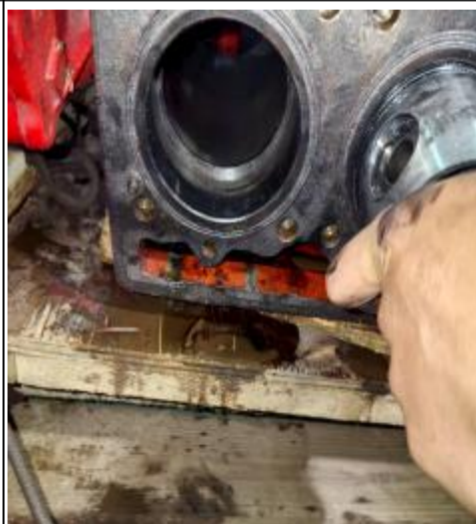
Check the piston and measure the clearance.

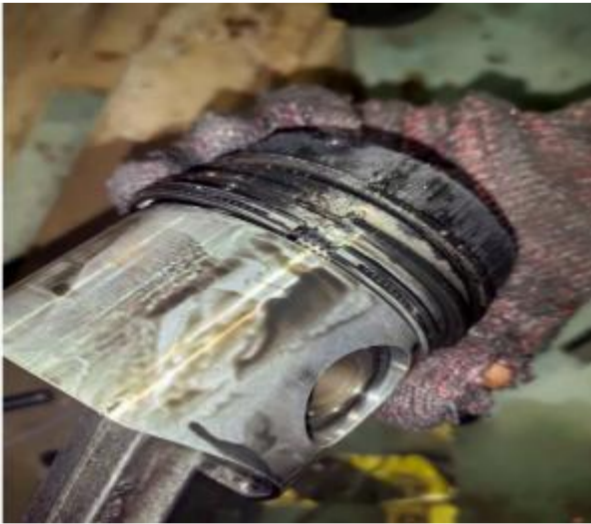
The piston ring clearance is excessive and no tension.

- 1 The two engine all repaired completely, and all in good condition.
- 2 All repairs and replacement were checked and supervised by superintendent.
- 3 The problems for the two engine:  
No.1 The "timing" was wrong"(gear skewing);Air valve excessive clearance;Piston ring excessive clearance tension.  
No.2 Air valve excessive clearance;crankshaft and connecting rod bearing abrasion;Piston ring excessive clearance and no tension.Crankshaft abrasion; Liner o-ring broken;Connecting rod with its press bloc were mismatch.High-pressure oil pump broken.

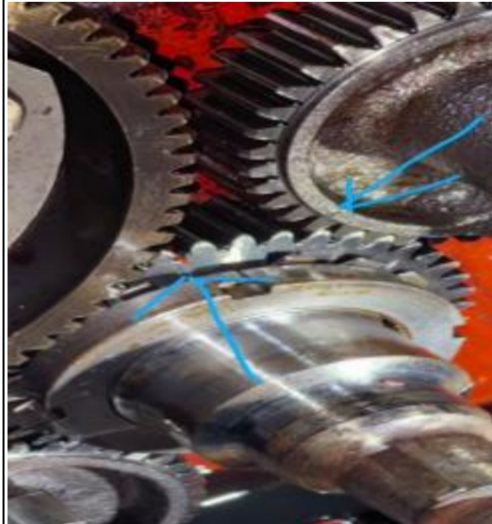
The "timing" has skewing two gears.

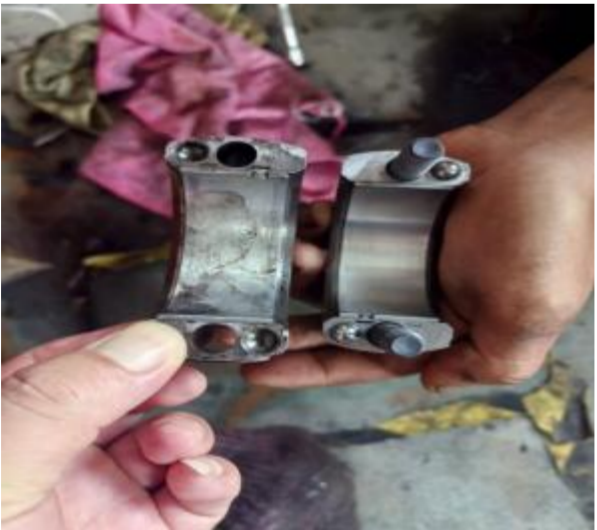
| The old and new bearing by comparison. | | cleaned the piston. |
