## Inspection Report

| Vessel name: | MV ANNA-MARIA | IMO No.: | 9407469 |

Attended on board as per customer's requirement to carry out inspection of hatch cover during DD in Fujian Huadong Shipyard.

Hatch cover: Folding type, total 5 cargo holds.  
Maker: Macgregor

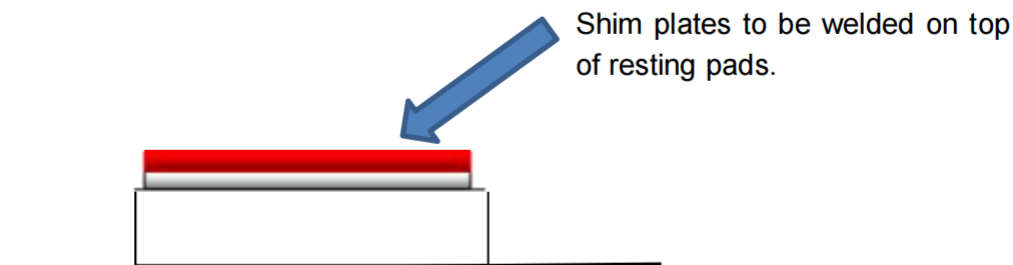
- Steel to steel bearing pad system. The bearing pads which would cause hatch cover sitting on coaming. The bearing pads will be adjusted by welding one shim plate on the top of resting pads. The bearing pads will be measured and adjusted in final step after renew the rubber packing.

- The sliding surface of bearing pads to be greased to reduce wears down.

- 1) Before fix the shim plates, the top of resting pad should grinding to smoothly.
- 2) Prepare sample plate 15x100x100mm 16pcs for gap measurement of resting pad.
- 3) Only tack welding for new shim plates before final checking. Hatch cover need to be closed for checking and confirm the adjustment of bearing pads, once satisfied, then full welding to be done.

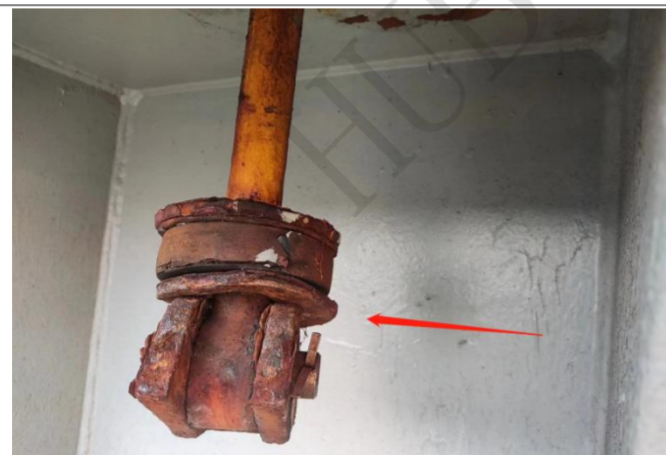
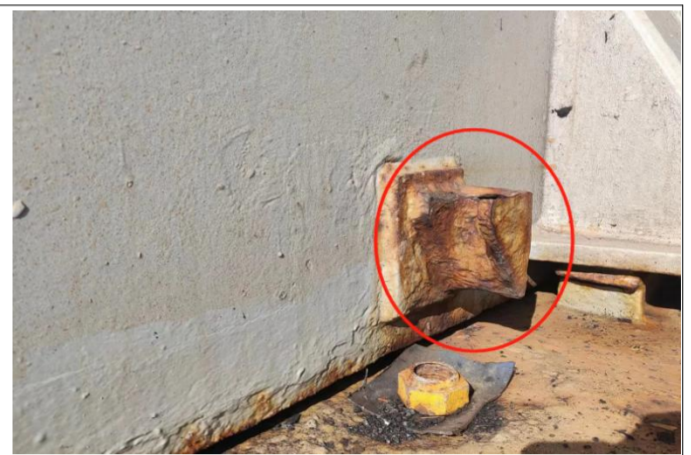
- Coaming top including the water drain gutter and rail tack way were rusty, suggest to be sandblasted and paint.
- The crutches of quick acting cleats were rusty, need to be descaled and paint. And quick acting cleats suggested to be removed for maintenance.
- The water drain valve was in normal, and water drain valves to be removed or plug the drain pipes for protecting the valves from sands/ dirty during dock repair. sandblasting. Before ship sailing , all drainage valve to be fit back in position and remove the plug to ensure the water drainage be free.

Drain gutter was rusty
