## SERVICE REPORT

Name of Ship: MV CMA CGM J MADISON Date: 25th Jul-3rd Aug, 2025

Port/Shipyard: SHEKOU & NINGBO PORT

Servcies: LIFEBOAT ENGINE REPAIR

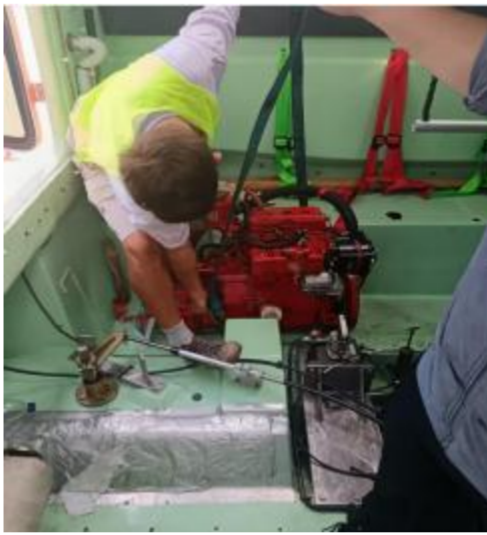
Lift out the engine and offland.

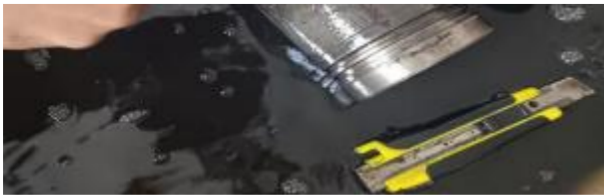
Rust remove the cylinder liner

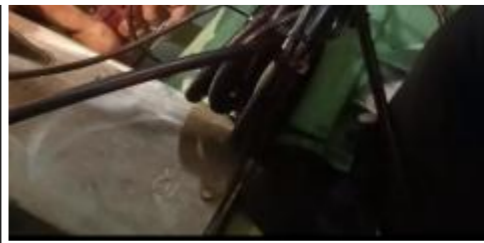
Wiring the No.1 engine.
