## SERVICE REPORT

Name of Ship: MV CMA CGM J MADISON Date: 25th Jul-3rd Aug, 2025

Port/Shipyard: SHEKOU & NINGBO PORT

Servcies: LIFEBOAT ENGINE REPAIR

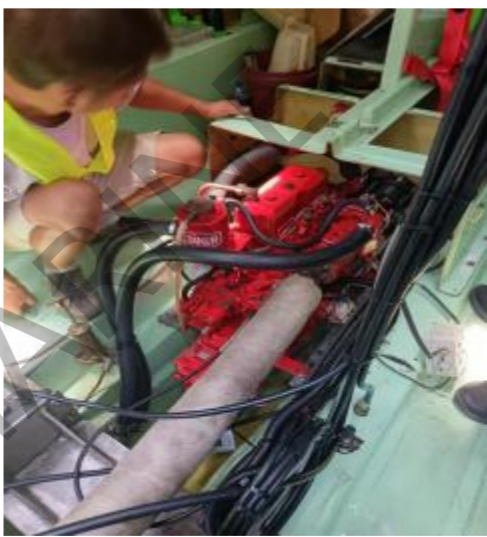
check the engine.

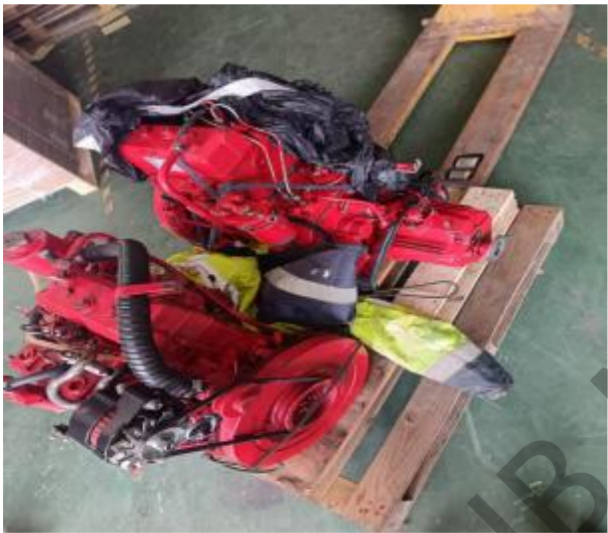
| The two engines arrived at our workshop. | | No.1 crankshaft oil seal leak oil. |

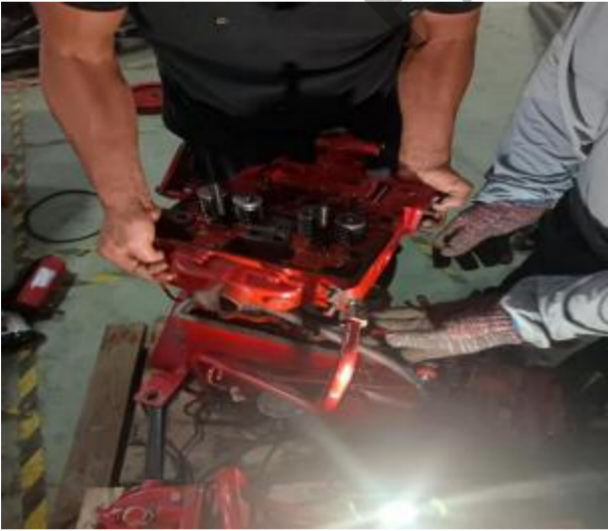
| Remove the No.1 cylinder head. | | Remove the oil pipe. |

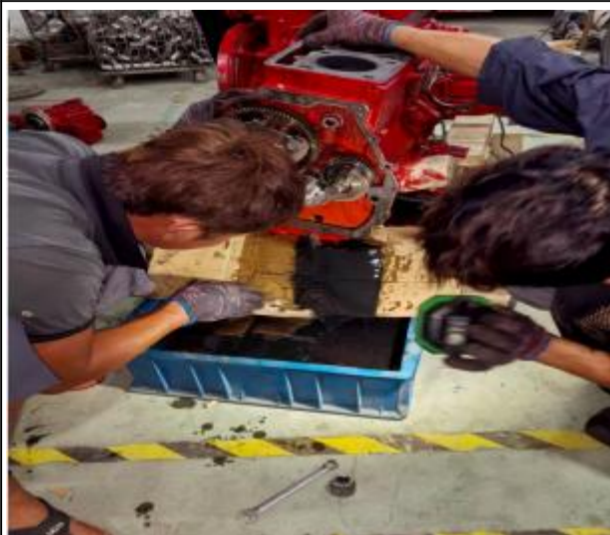
Drain the No.1 oil.

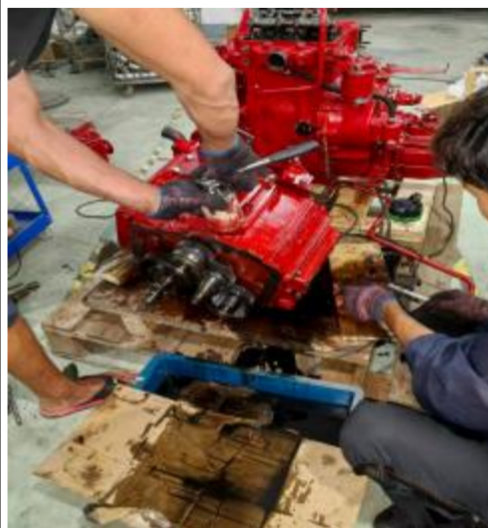
Remove the No.1 oil filter.

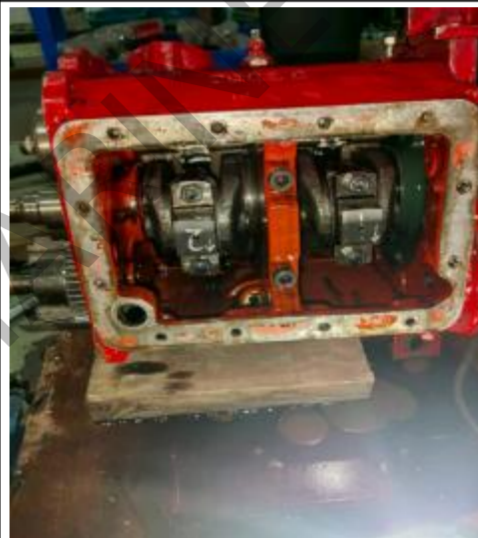
Mark the crankshaft connecting rod.

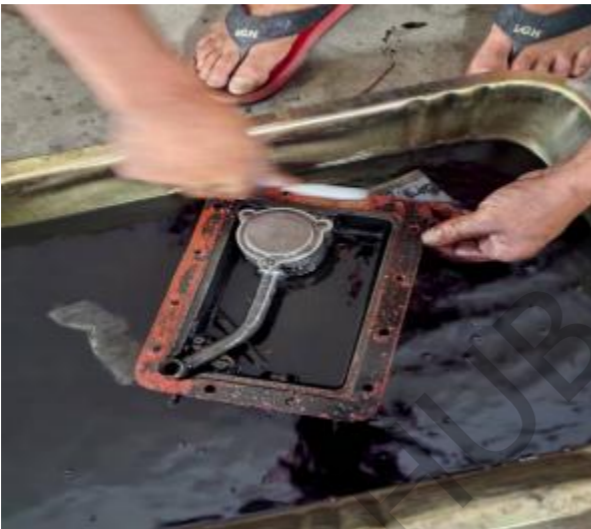
Clean the oil pan.

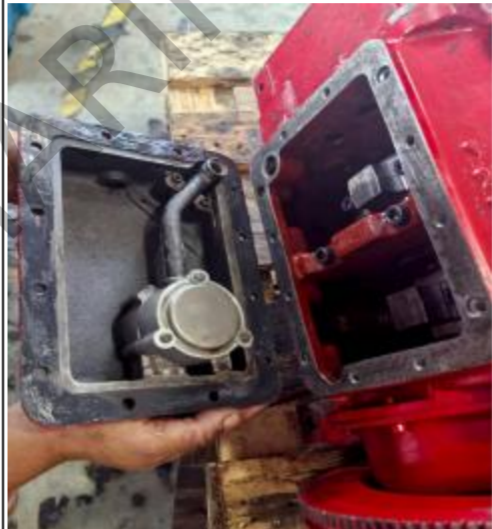
Refit the oil pan.

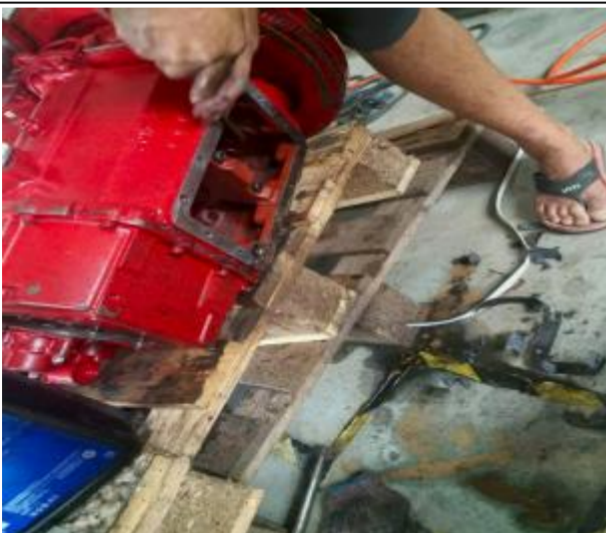
| Clean the old gaskets | | Tight the crankshaft bearing torsion. |

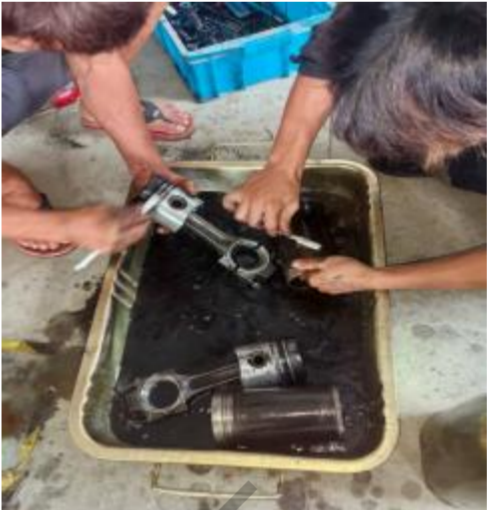
| The old and new bearing by comparison. | | cleaned the piston. |

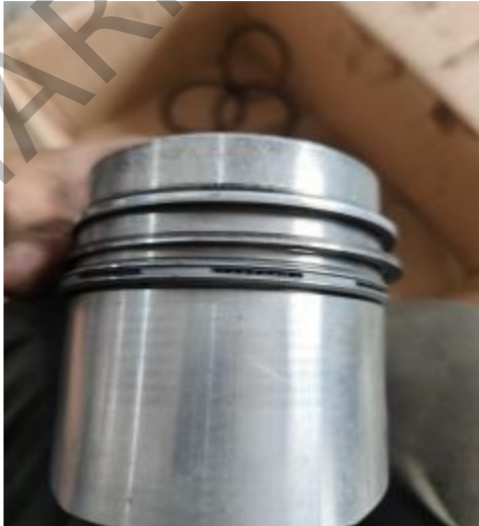
| Replace the piston ring. | | Replace the piston ring. |

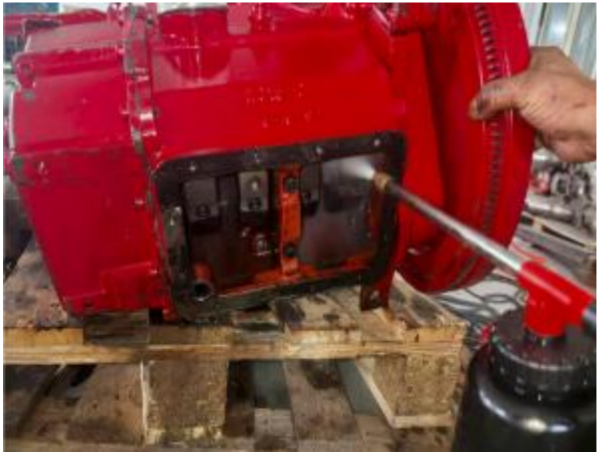
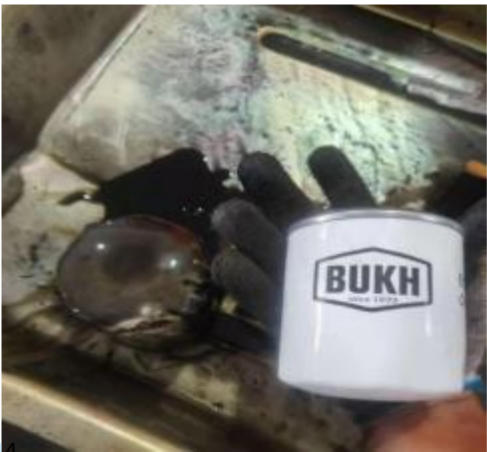
Clean the cylinder inside.

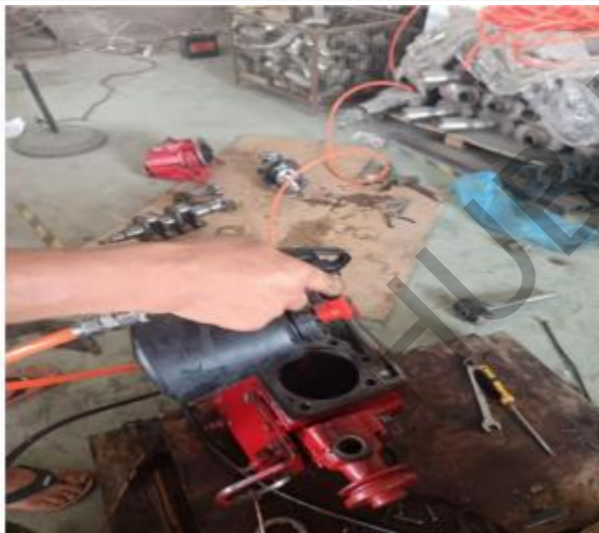
Cleaning the crankcase.

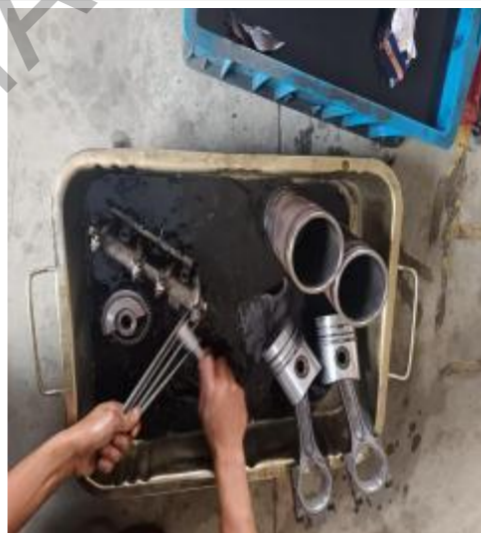
Cleaning the spare parts.

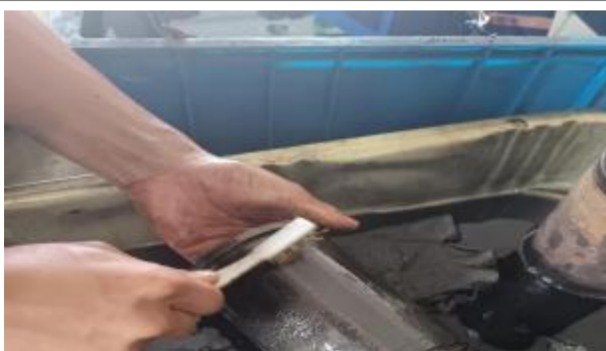
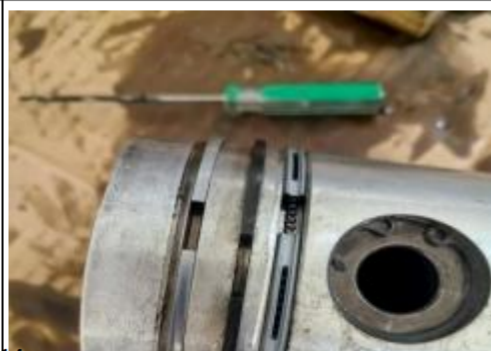
Rust remove the cylinder liner

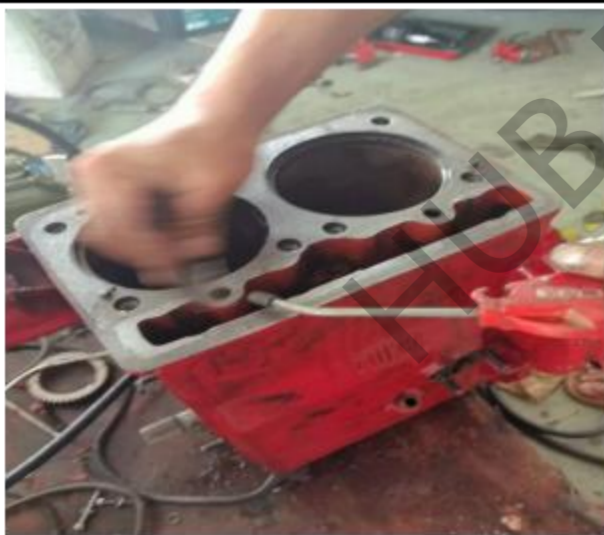
Clean the crankcase.

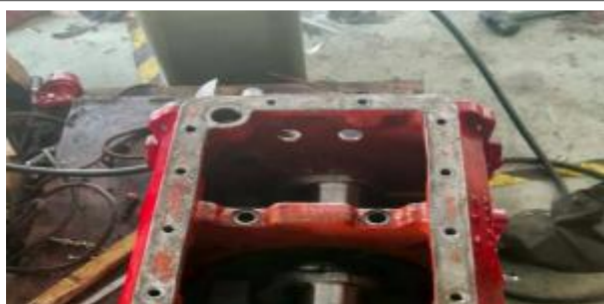
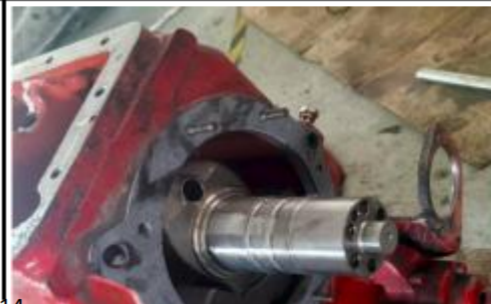
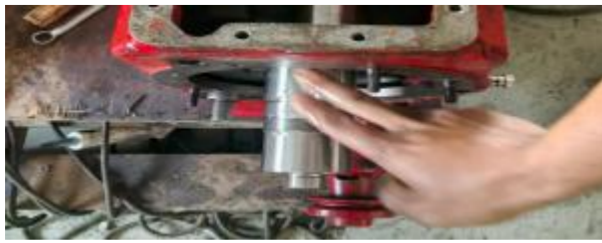
Install the crankshaft.

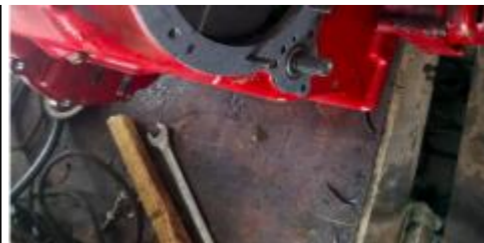
Replace the crankcase gasket.

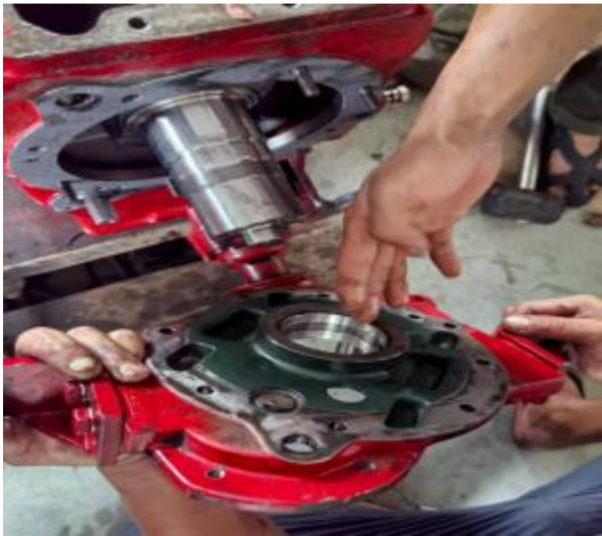
Install the crankcase before cover.

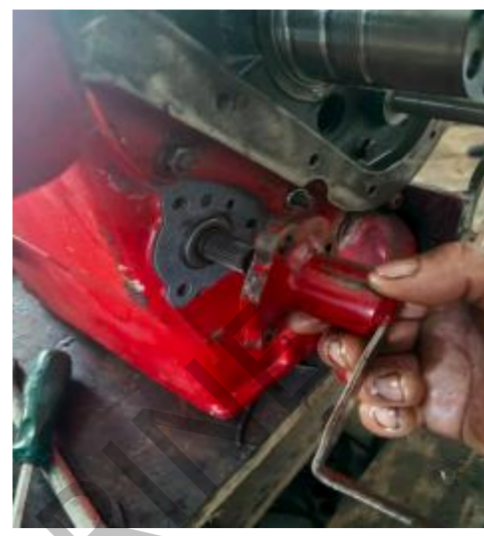
Install the flywheel timing pointer.

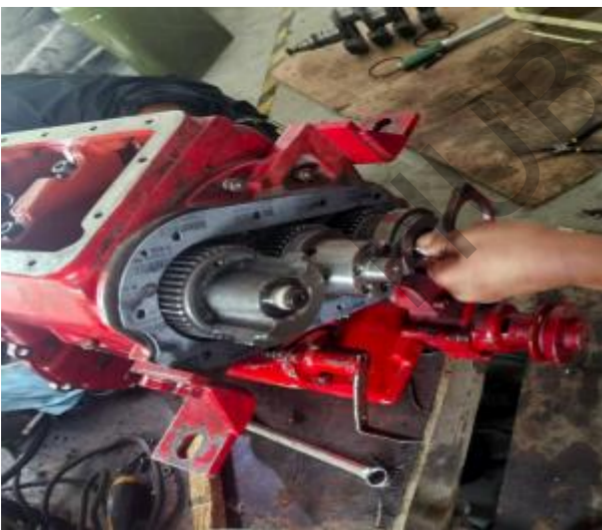
Install the crankcase before cover gearing.

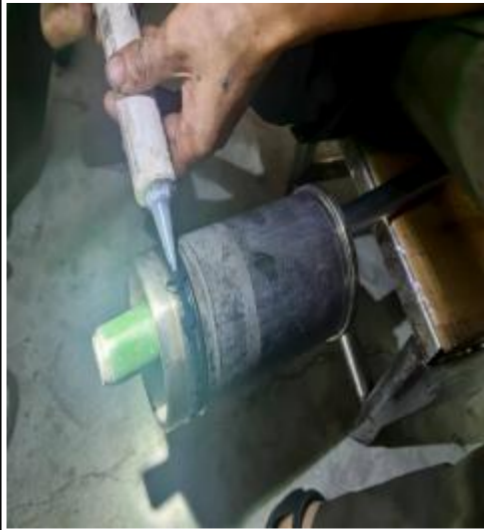
Coating the sealant for liner.

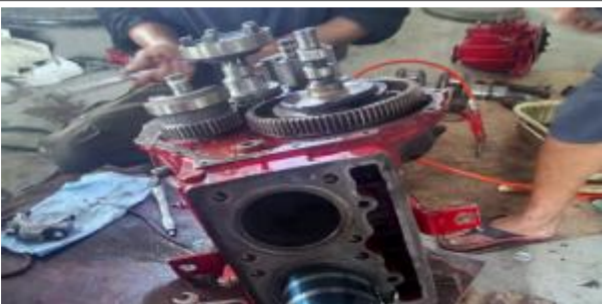
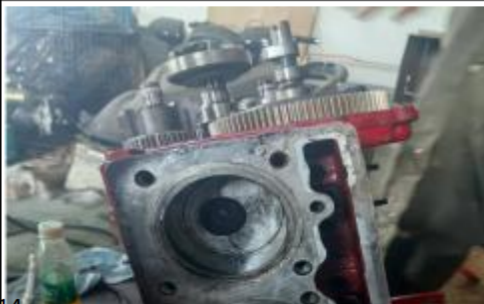
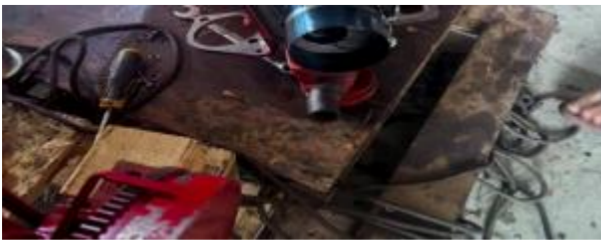
Install the connecting rod.

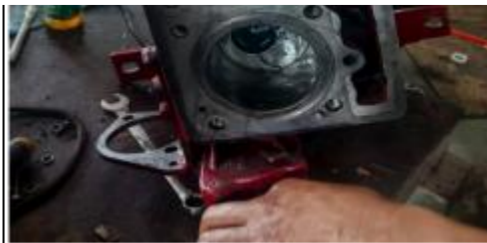
Install the piston.

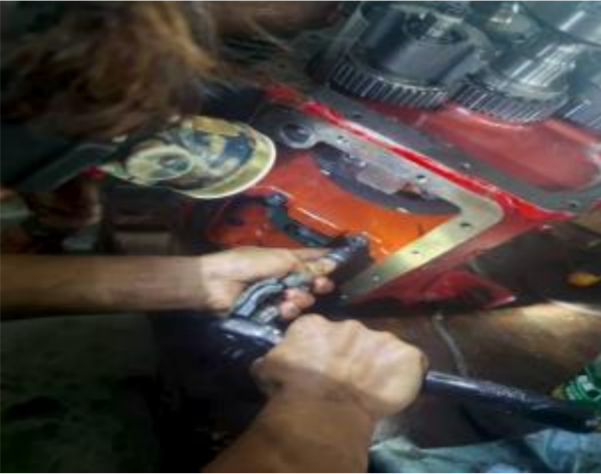
Fixed the crankshaft connecting rod bolts.

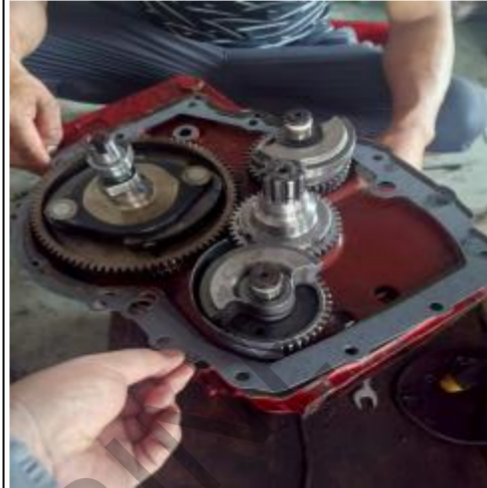
Install the aft crankcase gasket and gearing.

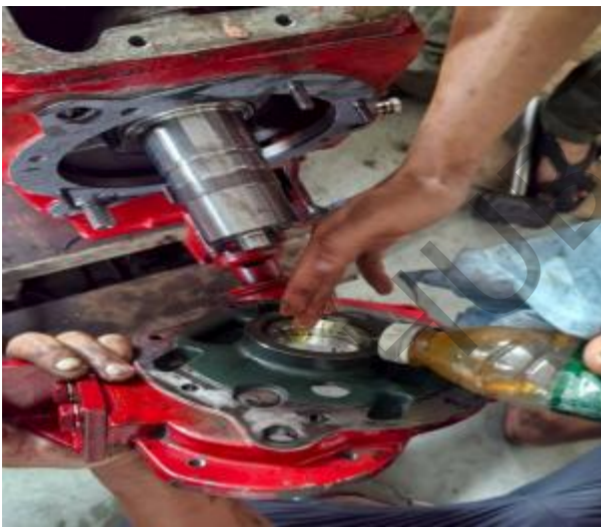
Lubricate the before crankcase connecting plate.

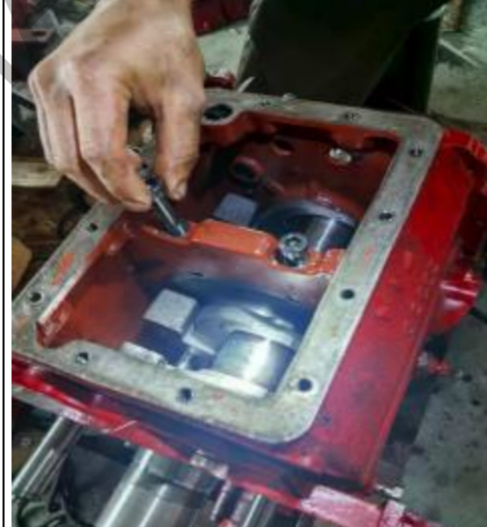
Install the bolts for the balance block.

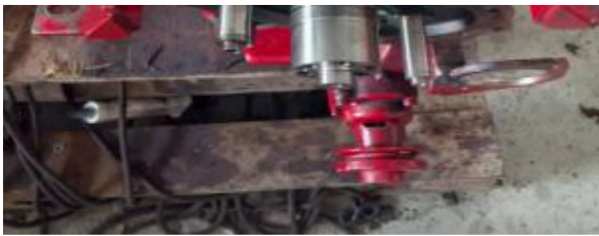
Install the before cover connecting plate.

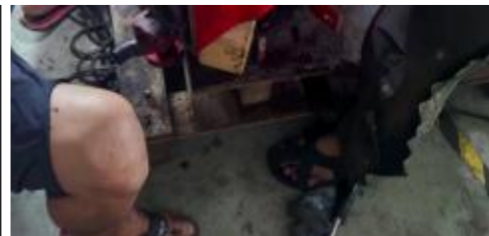
Install the aft crankcase cover.

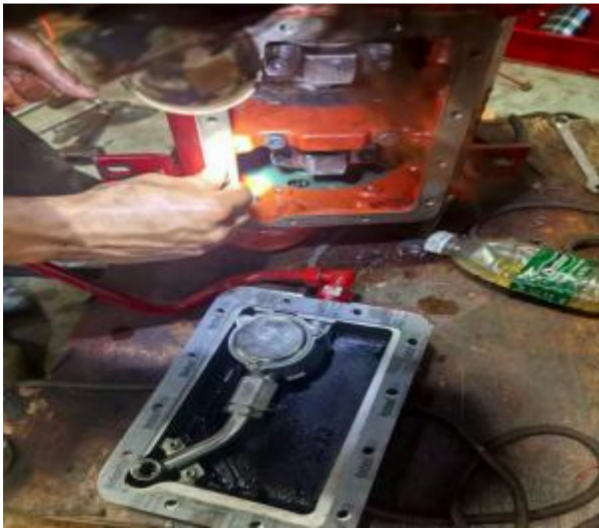
Install the oil pan.

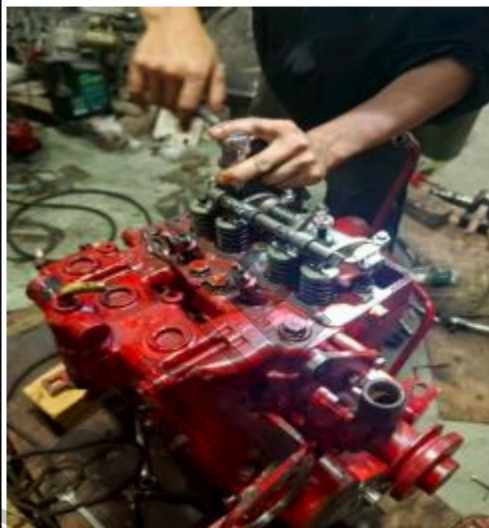
Install the cylinder head air valve.

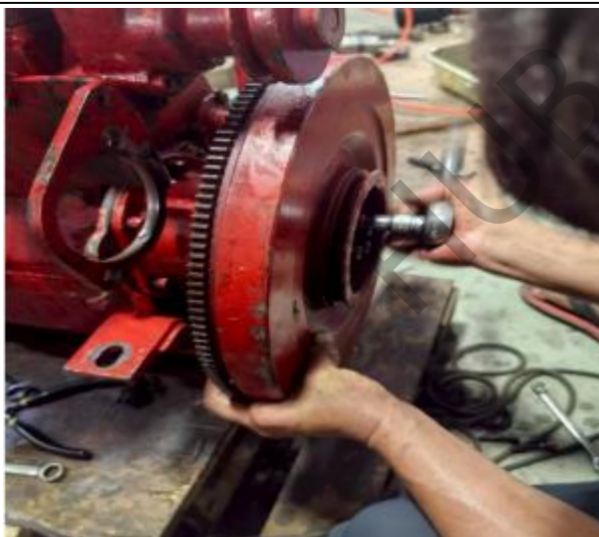
Install the flywheel disc.

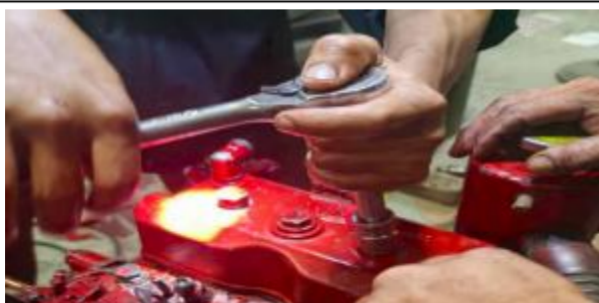
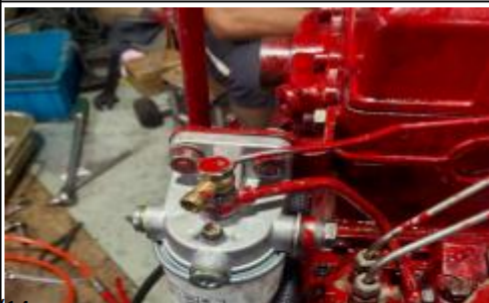
Adjust the air valve clearance.

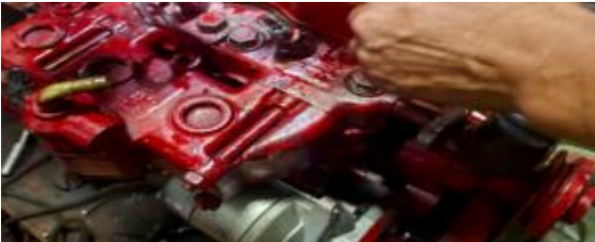
| Install the cavaera. | Replace the fuel filter. |

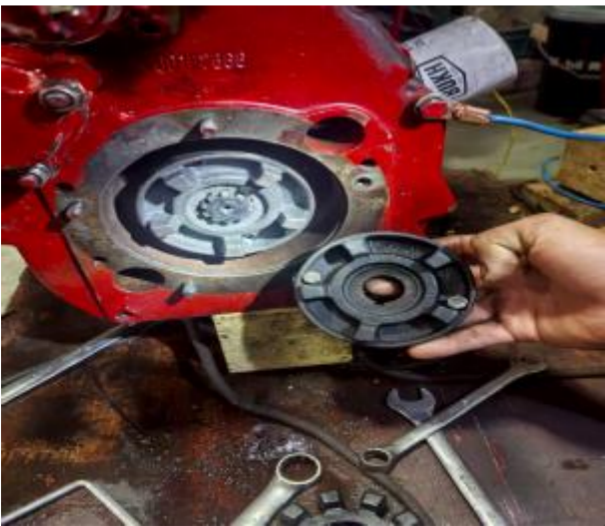
| Replace the coupling. | Test the No.2 engine.(video) |

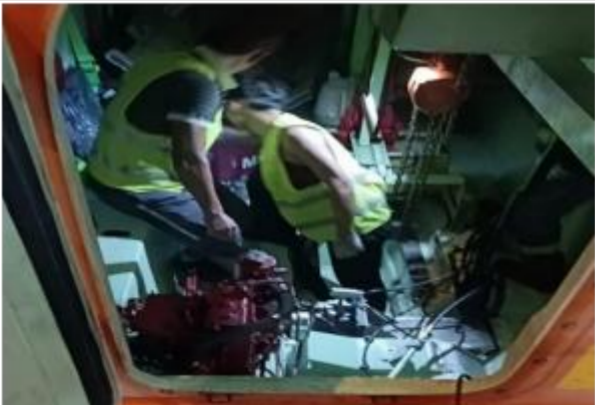
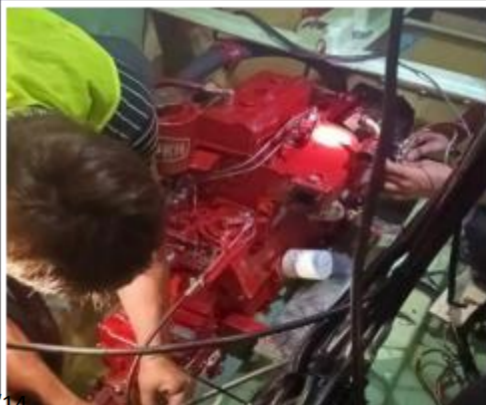
- 1 Installing the No.1 engine.
- 2 Testing the No.1 engine.

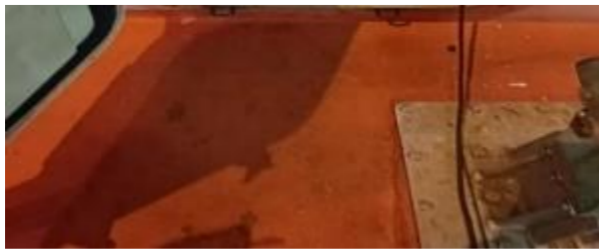
Install the No.1 engine.

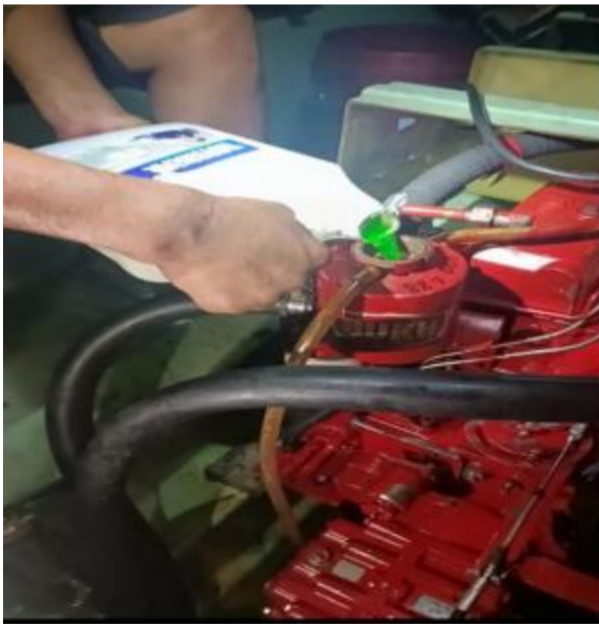
Add the antifreeze.

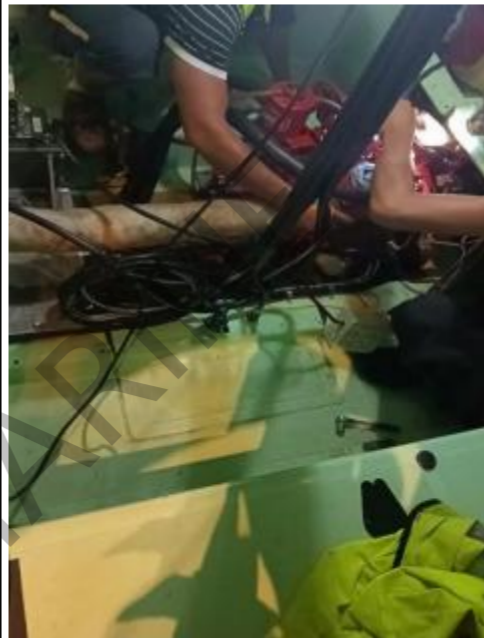
Install the exhaust pipe.
